Analysis of the 6 – 10 kV Cable Lines Faults in Vilnius City

B. Karaliūnas

The objective of the article is to evaluate Vilnius city 6 – 10 kV cable lines state and to set the reasons of their faults.

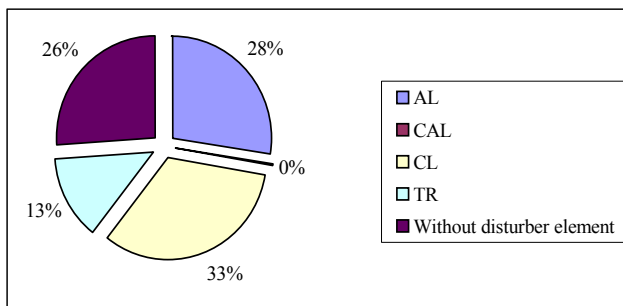
Fig. 3. Failure in distribution the general 10 kV electricity network: AL – aerial lines; CAL – cable aerial lines; CL – cable lines; TR – transformer substations

3. After reducing the number of cable tests applying high-voltage test there have appeared the increased number of emergency cases in the 6 – 10 kV cable network. The defects and faults in the network comprise 33% of the total faults, meanwhile the faults in the aerial lines comprise 28%, cable aerial lines make 26%, in the transformer substations there have been registered 13% faults.

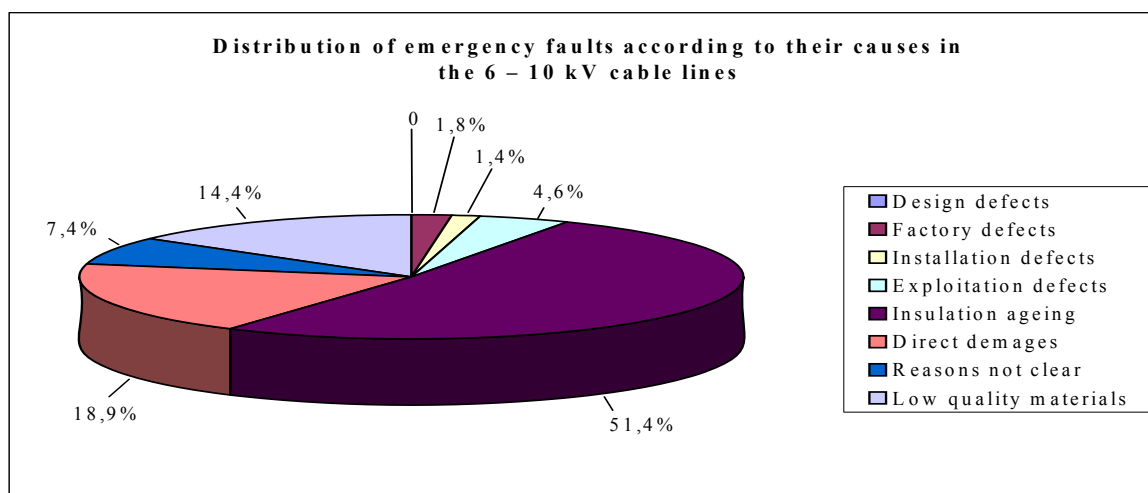
In 1960 – 1970 all the cables maintained are serviced preventively every year by testing them under the high – voltage test. At present in most European countries cables are tested with high – constant voltage before starting their maintenance. During the recent years in Vilnius region the capacities of cable tests have been reduced. That is why there have increased the number of faults in the old cable lines. Fig. 4 presents the idea mentioned above in the diagram.

Fig. 4. Distribution of emergency faults according to their causes in the 6 – 10 kV cable lines

4. In renovating the old cable lines as well as in laying out the new ones it is functional to recommend in Vilnius region to use power cables possessing insulation made from reinforced cross – linked polyethylene XLPE and operating as transversal and longitudinal water barriers.
