Analysis of the Power Blackout in the Marmara Earthquake

B. Oral, F. Dönmez

B. Oral, F. Dönmez. Analysis of the Power Blackout in the Marmara Earthquake // *Electronics and Electrical Engineering*. – Kaunas: Technologija, 2010. – No. 8(104). – P. 77–80.

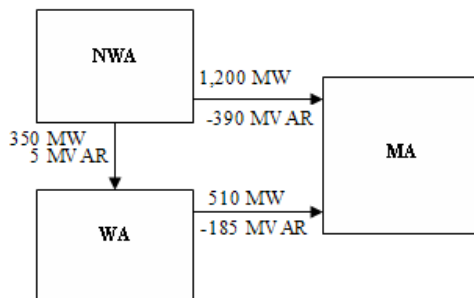
At the earthquake time, Turkish power system was fed mostly by thermal plants. Fig. 1 shows the power flow between the regions [10]. The view is that the power flow toward to east from west. In general, power flow of Turkish power system is from east regions, which have important hydroelectric power plants, to west regions, which have wealthy industrial facilities. However, at the earthquake time, the power flow was not like that. The Marmara Earthquake occurred in the summer of 1999. The summer was draught, and water levels of hydroelectric power plants were low in minimum and the power plant used for irrigation. At the same time, buying guarantee had to be applied for natural gas power plants; therefore, the natural gas power plants had to be on the service at the earthquake time.

Fig. 1. Power flow between the regions at minimum time range on 17th August, 1999

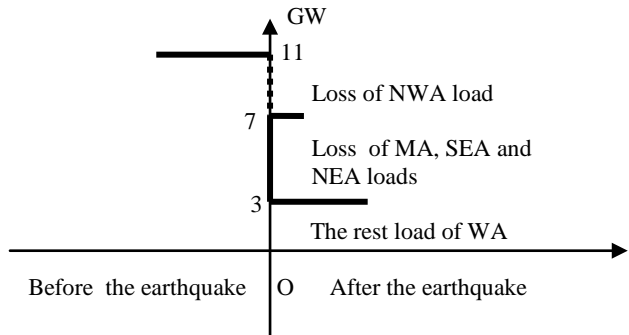
totally load of Turkey. Excluding the isolated regions total drawn load of MA, NEA and SEA was roughly 4.0 GW. Load of WA was roughly 3.0 GW and 30% of total drawn load of Turkey. Fig. 2 shows change of the system load at the earthquake [11]. Therefore, load of Turkish power system suddenly reduced. In the result of disturbances on the power system, cascading failures in the system were formed.

Fig. 2. Sudden load reduction of Turkish Power System in the Marmara Earthquake

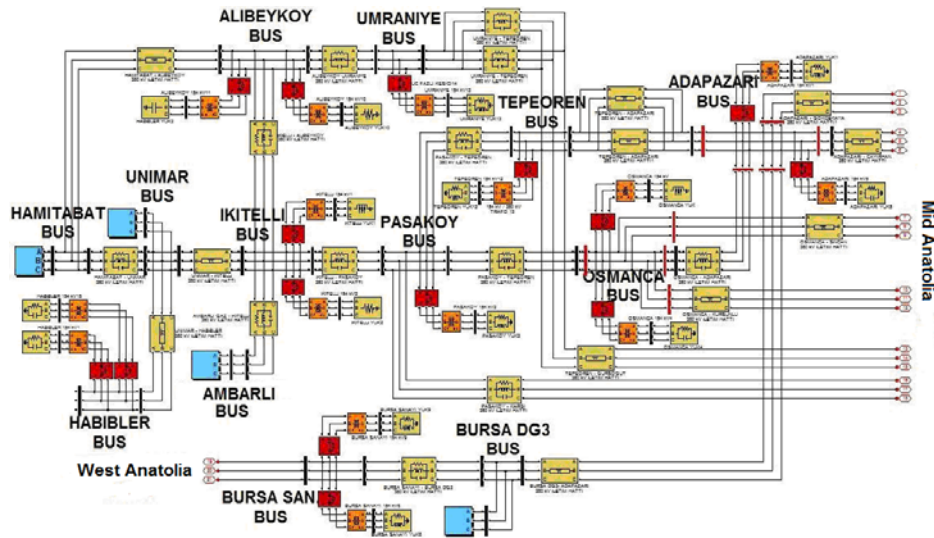
Fig. 3 shows power system of NWA region, which modeled by MATLAB. In fig. 3, you can only see NWA, but the Turkish power system was modeled completely in this study. In this context, at the earthquake time,

transmission and distribution lines of NWA were faults, which were breaking and short circuits in lines, and substations, which were severe earthquake regions, were opened by buchholz relays. In addition, middle voltage and low voltage substations caused damage, so, immediately

after the earthquake; the region load was rejected suddenly. At the same time, connection substations, between NWA and MA, suffered damage, when power was flowing from NWA to WA.

Fig. 3. MATLAB model of Northwest Anatolia Power System

Because of the earthquake, load rejection of NWA region and opening of connection between NWA and WA were expressed for $t=1.0$ s. and Turkish power system was simulated immediately after a transient process started.

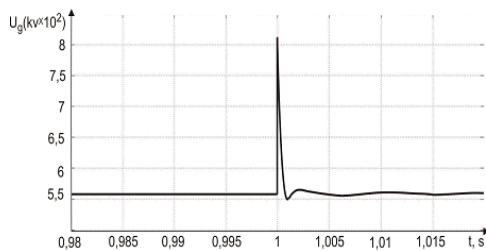
Fig. 4 shows voltage of Umraniye Bus. It is substation of 380 kV and 154 kV in Anatolia side of Istanbul. This profile was captured at the bus of 380 kV and we can see that voltage sharply increased at $t=1.0$ s. The increase was roughly 1.5 per unit.

Fig. 4. Voltage of Umraniye Bus

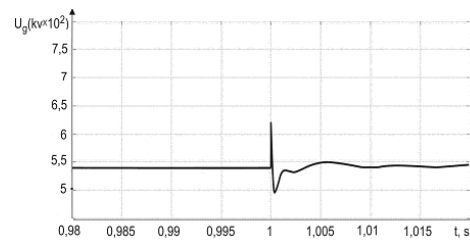
Fig. 5 shows the voltage of Bursa San Bus. This substation is between WA and NWA regions. After the Marmara earthquake, cities of WA region did not experience power outages. Generation of this region was balanced the consumption and the region demand was supplied by their own power plants under 154 kV. The voltage of the bus increased 1.1 per unit.

Fig. 5. Voltage of Bursa San Bus

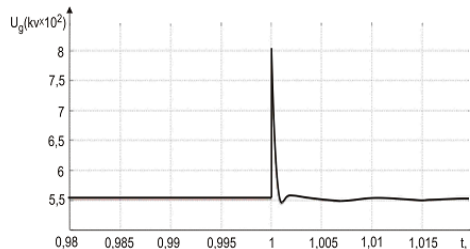
Fig. 6 presents voltage of Golbasi Bus. Voltage of this bus also increased. But, the increasing was different from Bursa San Bus, especially. Since the bus was affected badly, voltage increasing was almost the same as Umraniye Bus.

Fig. 6. Voltage of Golbasi Bus
