Analysis of the Power Blackout in the Marmara Earthquake

B. Oral, F. Dönmez

*Department of Electrical Education, Marmara University,
Goztepe Campus, Kadikoy, Istanbul, Turkey, phone: +90 216 3365770, e-mail: boral@marmara.edu.tr*

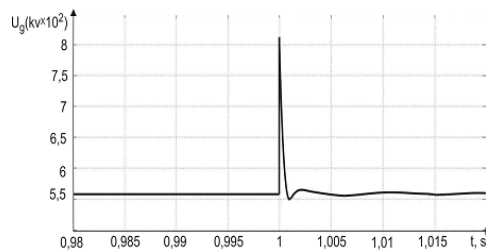
Fig. 4 shows voltage of Umraniye Bus. It is substation of 380 kV and 154 kV in Anatolia side of Istanbul. This profile was captured at the bus of 380 kV and we can see that voltage sharply increased at $t=1.0$ s. The increase was roughly 1.5 per unit.

Fig. 4. Voltage of Umraniye Bus

The analysis of MATLAB shows that voltages of buses increased between 1.2 and 1.5 per unit. When the load drops too low, there can be an overvoltage condition. This increase in voltage may go as high as 2.0 per unit value with 400 kV lines. At the Marmara Earthquake, the Turkish power system experienced overvoltage conditions.

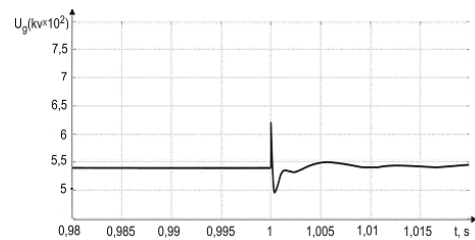
Fig. 5 shows the voltage of Bursa San Bus. This substation is between WA and NWA regions. After the Marmara earthquake, cities of WA region did not experience power outages. Generation of this region was balanced the consumption and the region demand was supplied by their own power plants under 154 kV. The voltage of the bus increased 1.1 per unit.

Fig. 5. Voltage of Bursa San Bus

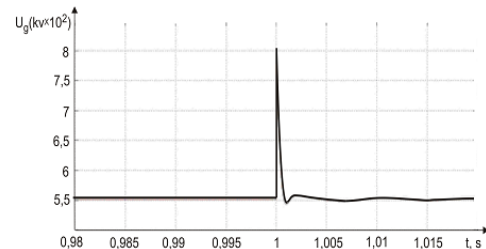
Fig. 6 presents voltage of Golbasi Bus. Voltage of this bus also increased. But, the increasing was different from Bursa San Bus, especially. Since the bus was affected badly, voltage increasing was almost the same as Umraniye Bus.

Fig. 6. Voltage of Golbasi Bus
